GENERAL INFORMATION

CHARACTERISTICS OF WELL

MOULTON CORNER COMMUNITY, LIBERIA (REHAB WELL)

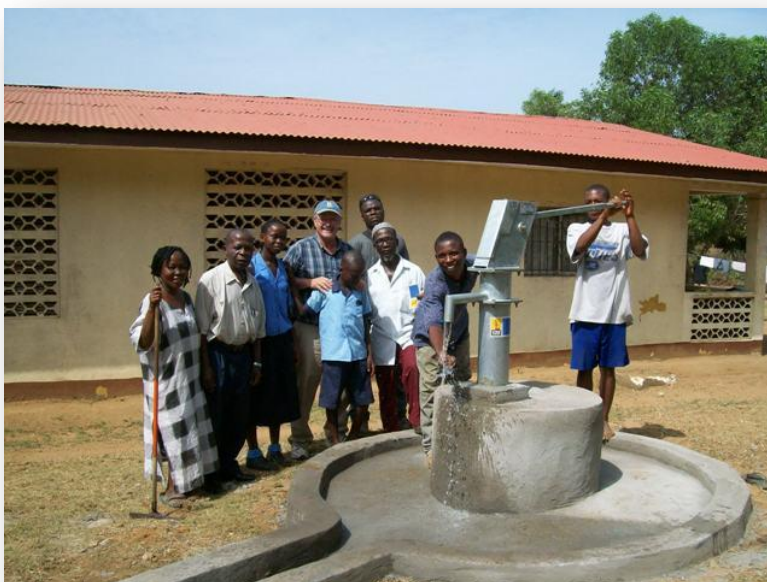
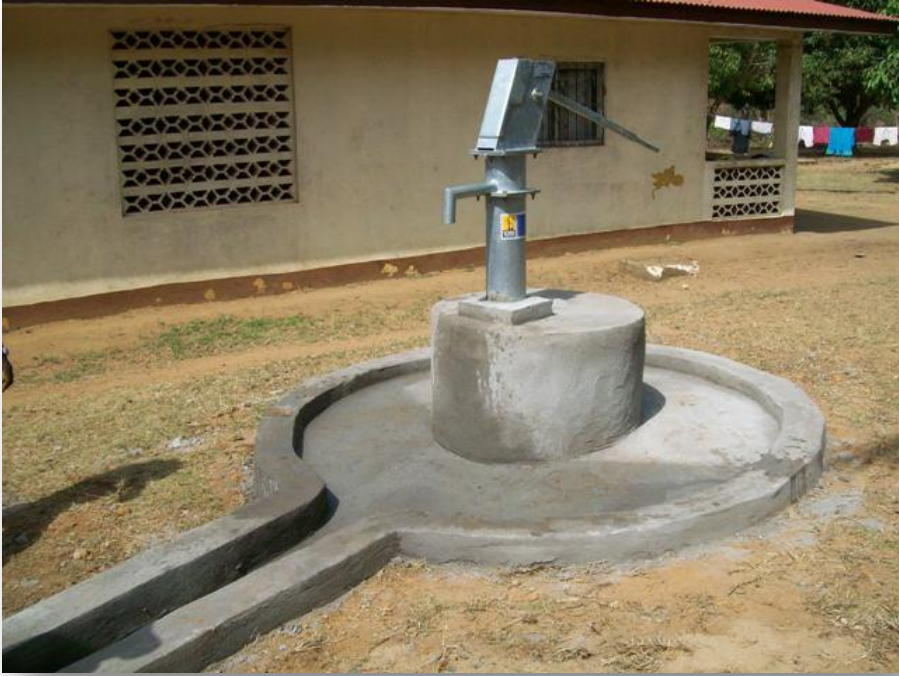
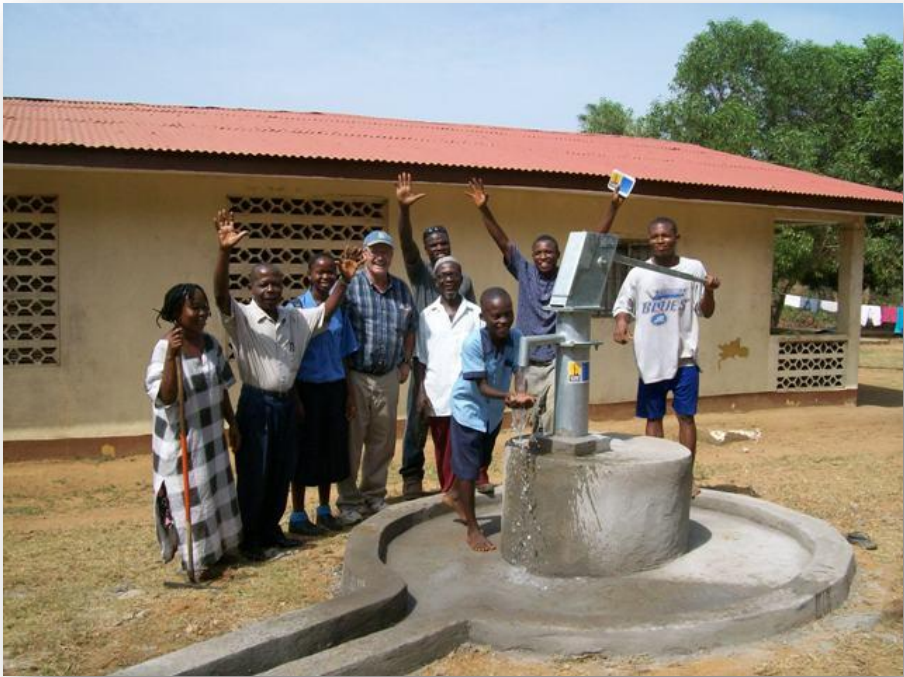
The LWI Liberia team rehabilitated the open top well by cleaning out the debris and sealing up the well with a pump base. The team also chlorinated the well and installed a new India Mark II hand pump. Moulton community is now enjoying clean, safe water. The hygiene team taught the community how to keep their pump and the well site clean. The team also demonstrated how someone can carry germs and how to prevent themselves from getting infected with bacteria.
