GENERAL INFORMATION

CHARACTERISTICS OF WELL

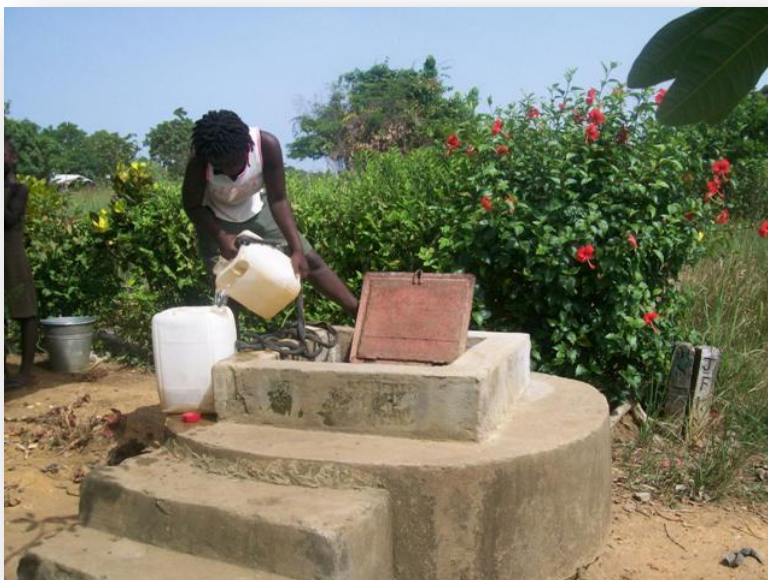
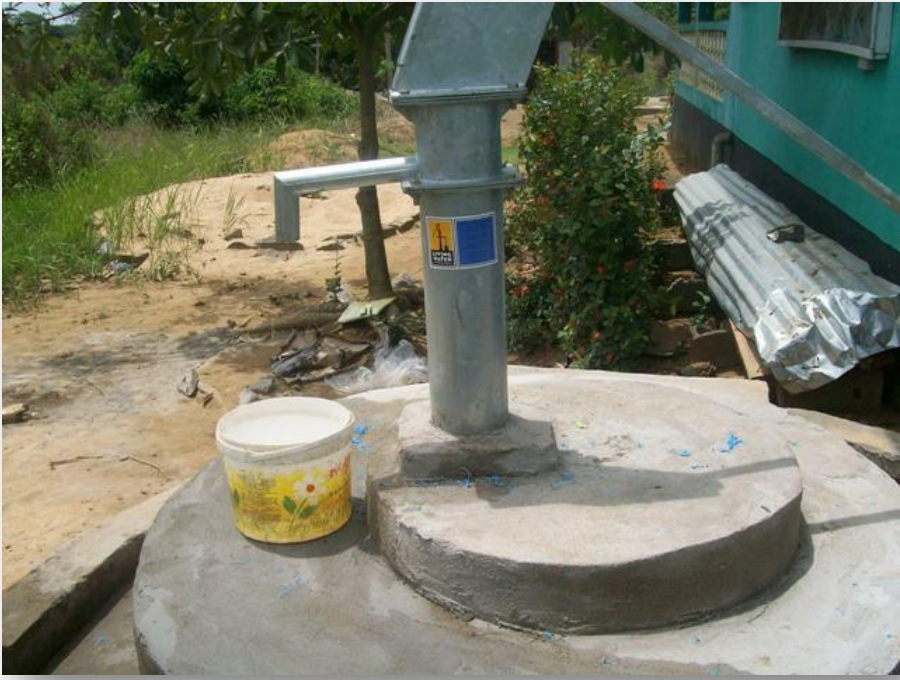
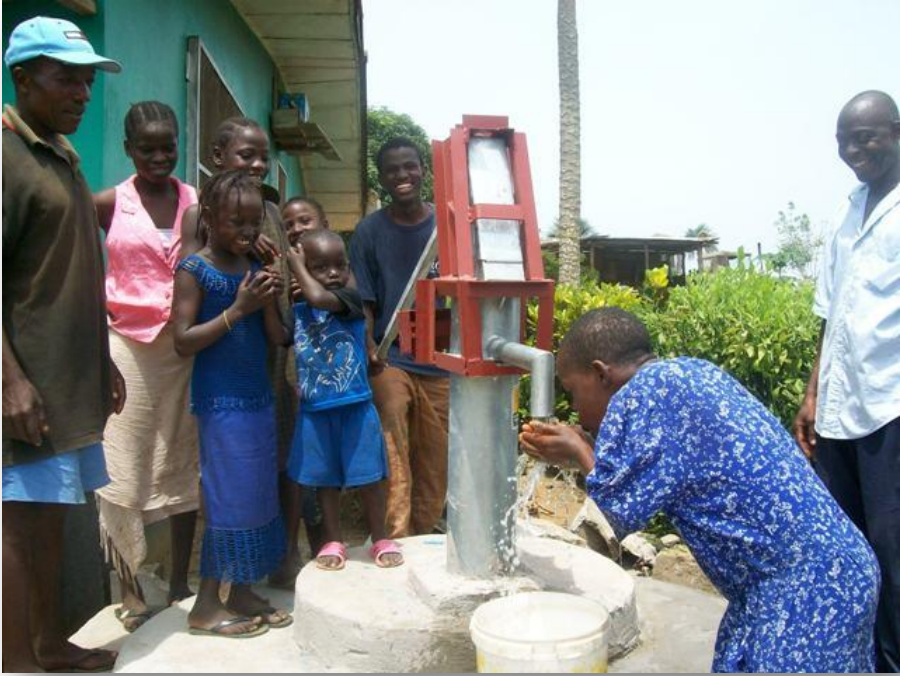
PHOTOS

This community does not have a clinic and most of the people are unemployed. The LWI Liberia team rehabilitated the well by cleaning out the debris, closing the well, putting in a pump base and chlorinating the well. The team also built a concrete apron and installed a new India Mark II hand pump. Unity community now has a clean, safe source of water. The team instructed the people how to keep the area around the pump clean along with how to wash their hands properly and how to properly store water.
